# NEW YORK STATE DEPARTMENT OF ENVIRONMENTAL CONSERVATION

January 14, 2022

Re: Lower Wee-Wah Lake Dam  
DEC Dam ID#: 196-0361, Class C – High Hazard  
Village of Tuxedo Park, Orange County  
**Condition Rating: No Deficiencies Noted**

**Visual Observations**

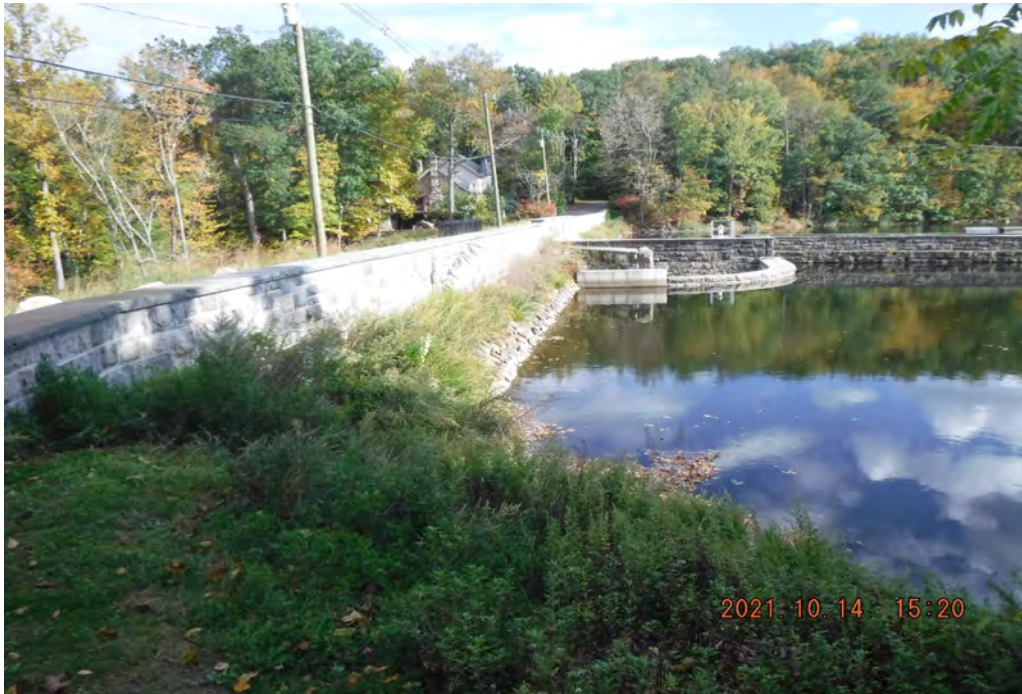
–Tall grass and weeds growing from between the stones on both the left and right upstream slopes

**Photo 1 Dam ID# 196-0361 Lower Wee-wah Lake Dam 10/14/2021**  
Left upstream slope  
View looking right from left end of dam

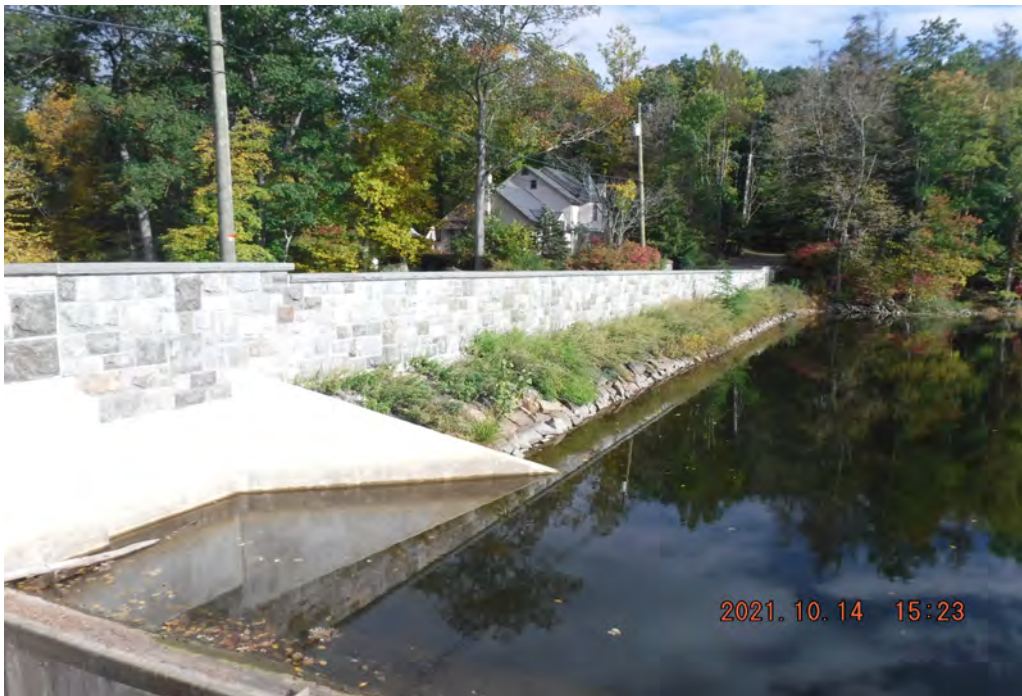
**Photo 2 Dam ID# 196-0361 Lower Wee-wah Lake Dam 10/14/2021**  
Right upstream slope  
View looking right from spillway channel

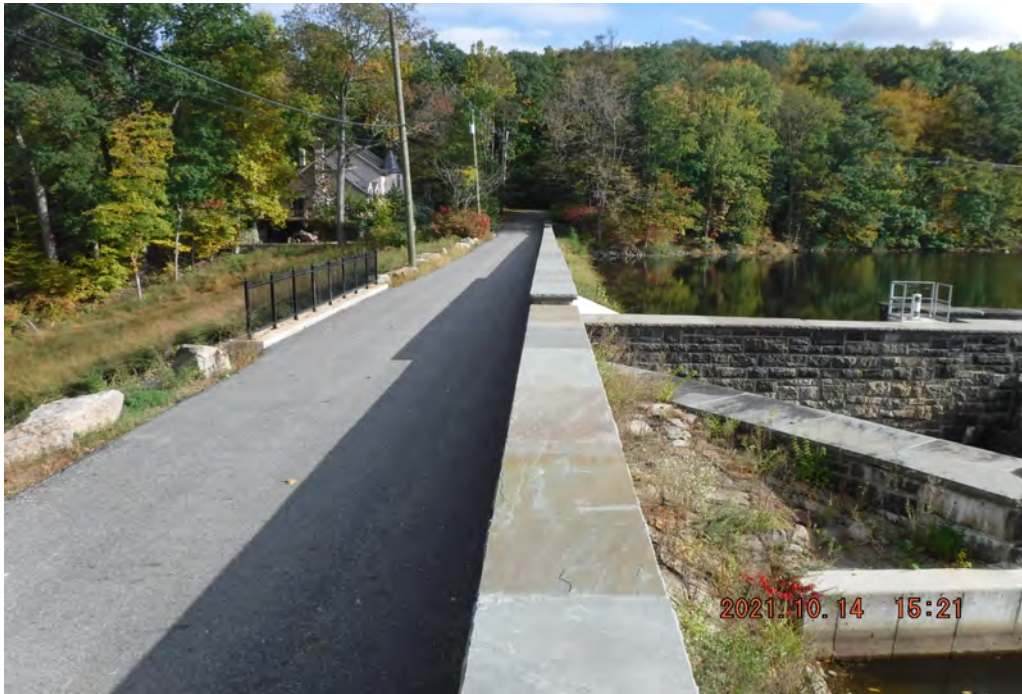
–Dam crest is access road. Road and upstream parapet wall appear OK

**Photo 3 Dam ID# 196-0361 Lower Wee-wah Lake Dam 10/14/2021**  
Dam crest  
View looking right from left side of dam

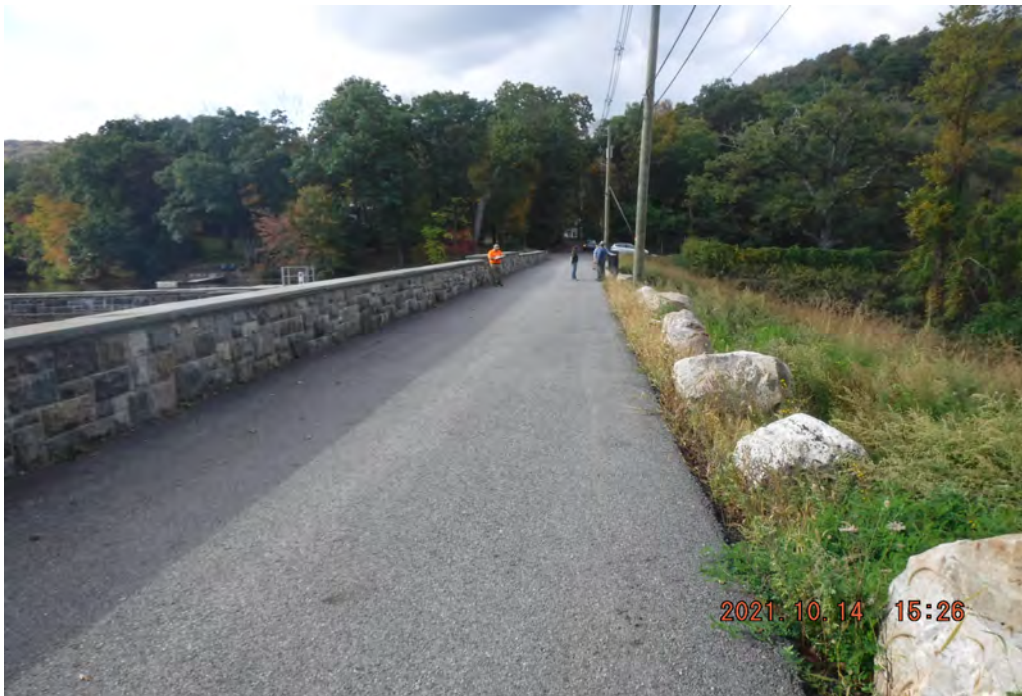
**Photo 4 Dam ID# 196-0361 Lower Wee-wah Lake Dam 10/14/2021**  
Dam crest  
View looking left from right end of dam

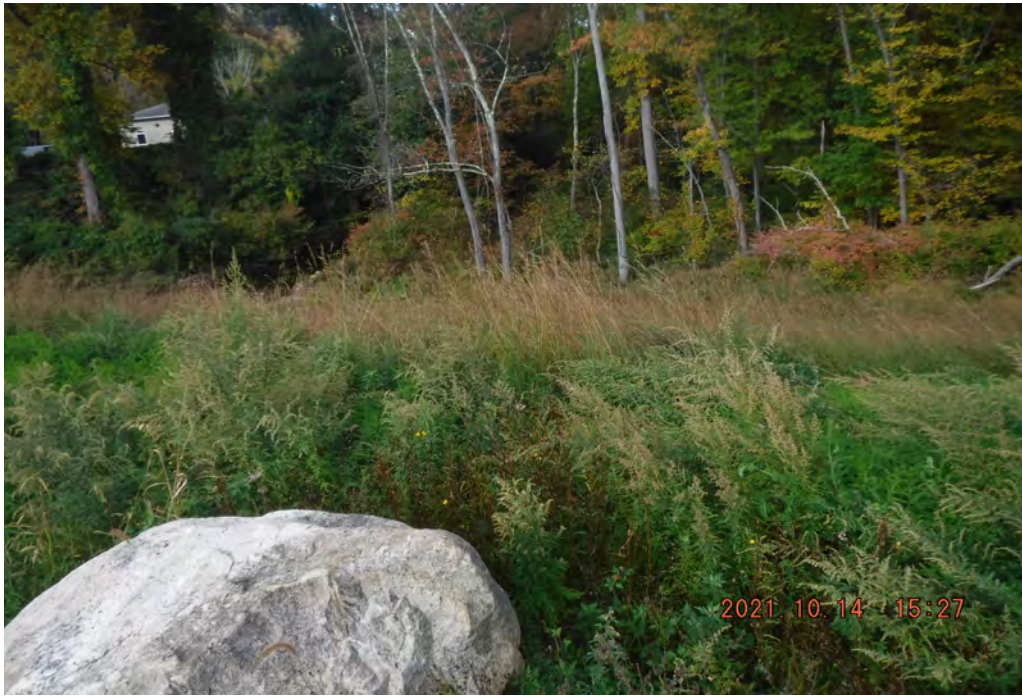
–Both left and right downstream slopes are overgrown with tall grass and weeds. Grass obscured slopes so that a visual inspection could not be completed  
–V-notch weir box for right side downstream toe drain reading was approx. 2-inches (gauge hard to read from staining).

**Photo 5 Dam ID# 196-0361 Lower Wee-wah Lake Dam 10/14/2021**  
Right downstream slope  
View looking downstream from crest

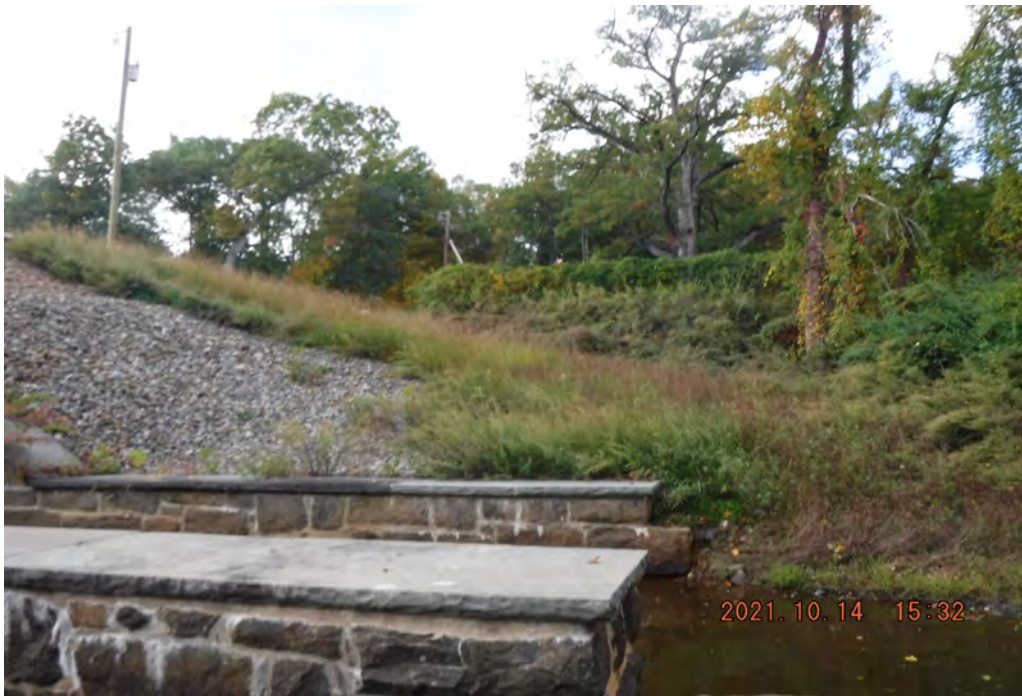
**Photo 6 Dam ID# 196-0361 Lower Wee-wah Lake Dam 10/14/2021**  
Left downstream slope  
View looking left from right side of spillway

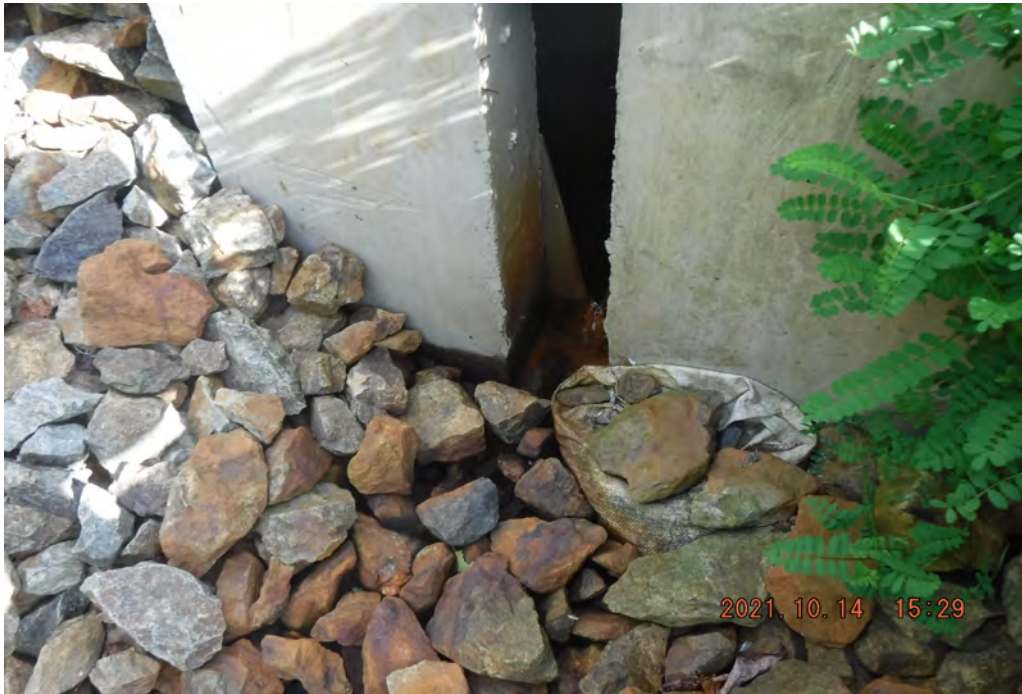
**Photo 7 Dam ID# 196-0361 Lower Wee-wah Lake Dam 10/14/2021**  
Weir box for right downstream toe drain

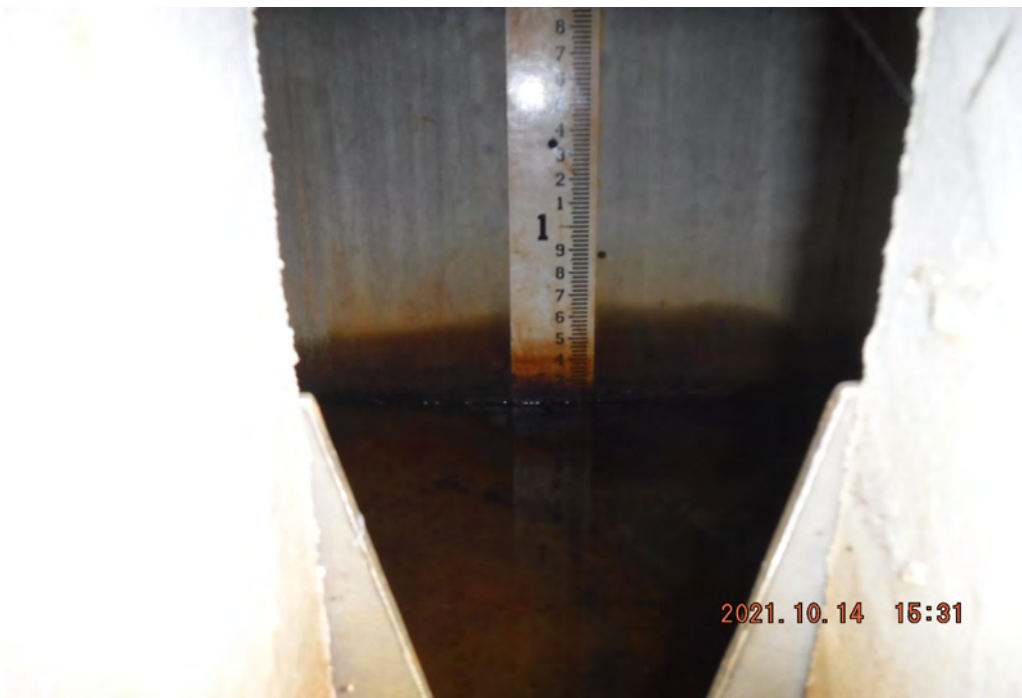
**Photo 8 Dam ID# 196-0361 Lower Wee-wah Lake Dam 10/14/2021**  
Inside weir box for right downstream toe drain  
Gauge reads 2-inches +/-

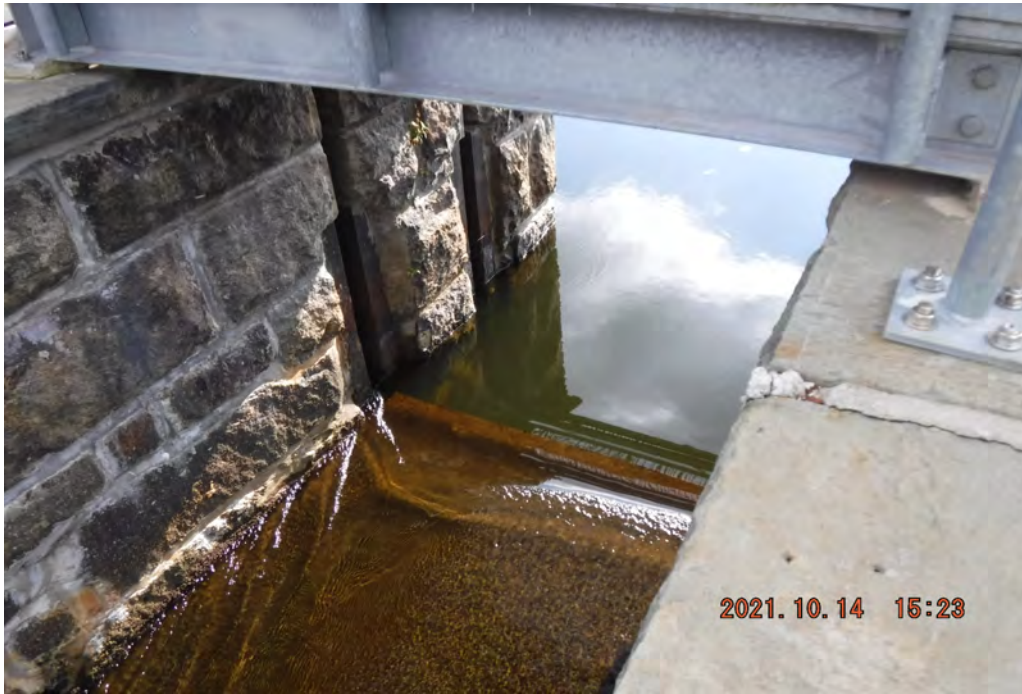
–Boards in place. No noted deficiencies

**Photo 9 Dam ID# 196-0361 Lower Wee-wah Lake Dam 10/14/2021**  
Primary spillway inlet with stop logs  
View looking upstream from left side

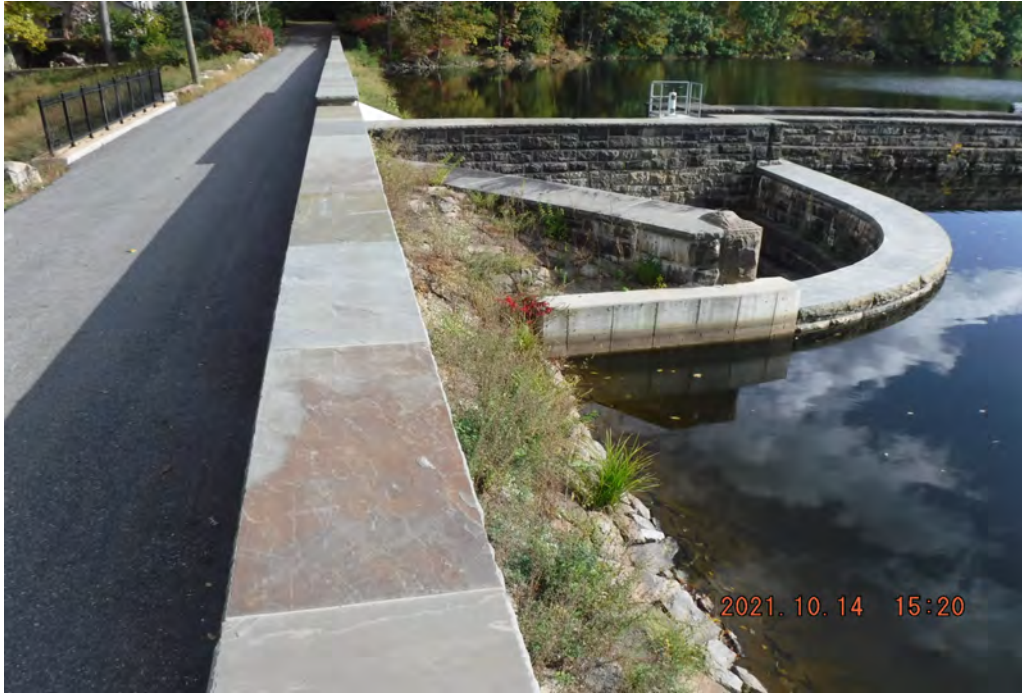
–Several locations of seepage through the base of the spillway face and on the spillway floor with orange staining.

**Photo 15 Dam ID# 196-0361 Lower Wee-wah Lake Dam 10/14/2021**  
Auxiliary spillway  
View looking right from the left side

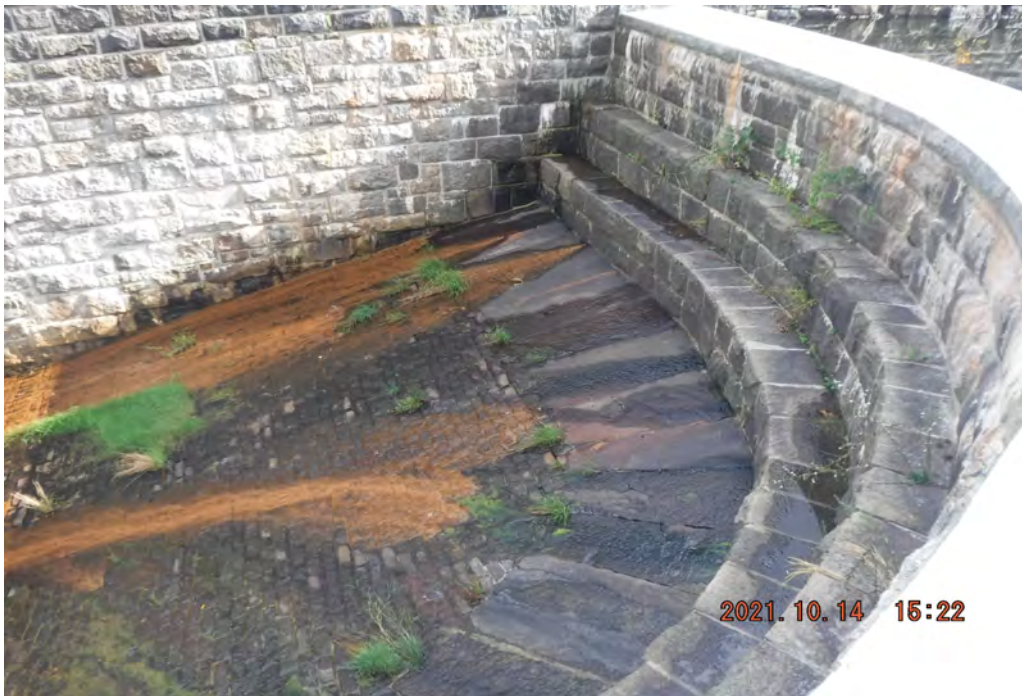
**Photo 16 Dam ID# 196-0361 Lower Wee-wah Lake Dam 10/14/2021**  
Downstream face of auxiliary spillway  
View looking upstream to the right from dam crest  
Note: seepage through spillway floor
