NEW YORK STATE DEPARTMENT OF ENVIRONMENTAL CONSERVATION

January 13, 2022

Re: Tuxedo Lake Dam
DEC Dam ID#: 196-0354 (Class B – Intermediate Hazard)
Village of Tuxedo Park, Orange County

Visual Observations

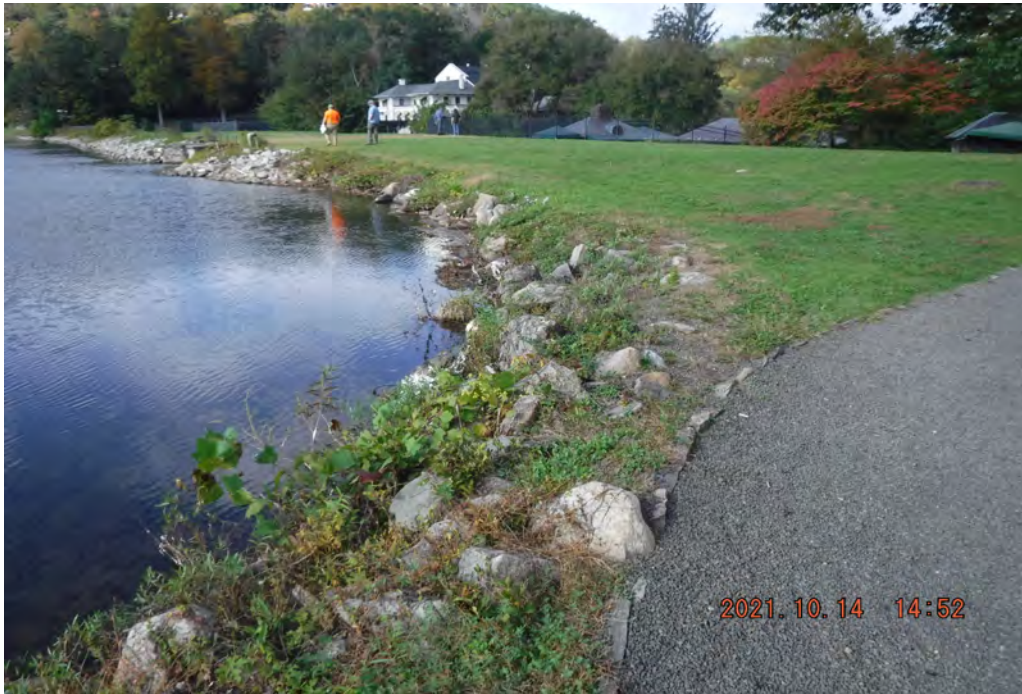
Photo 1 Dam ID# 196-0354 Tuxedo Lake Dam 10/14/2021
Right end of upstream slope
View looking left from right end of dam

- Upstream slope is lined with rip rap wave protection. Rip rap appears in place.
- Minor vegetation and light brush growing up between the stones to the right of the spillway
- Brush and heavier vegetation observed in the center of the dam near the old concrete steps

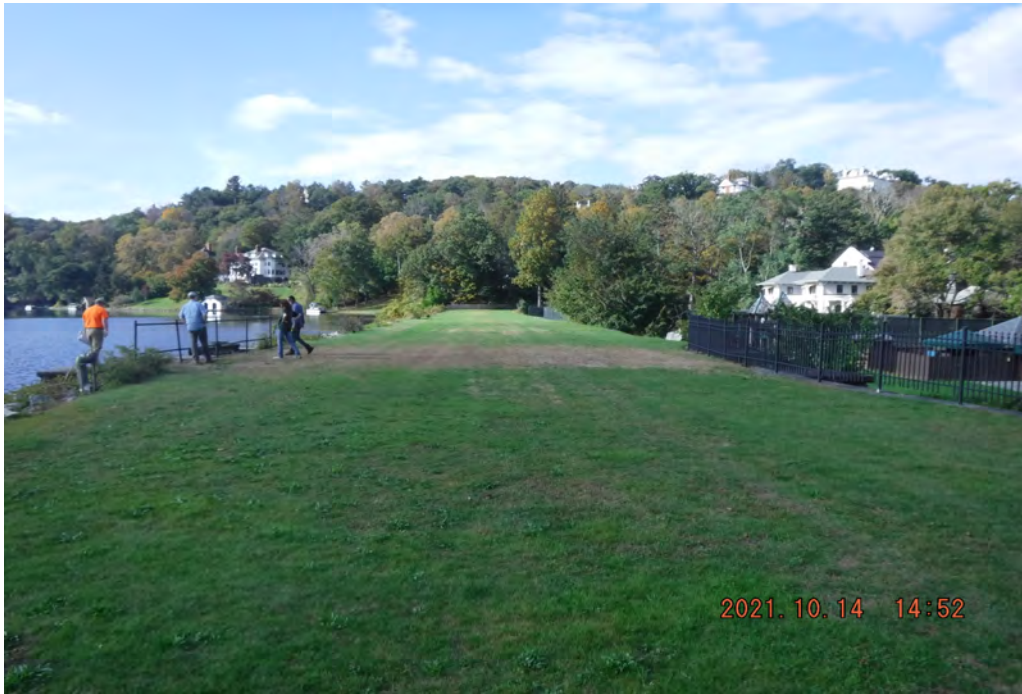
Photo 5 Dam ID# 196-0354 Tuxedo Lake Dam 10/14/2021
Dam crest
View looking left from right end of dam

–Crest is grass covered, appears level and well maintained.

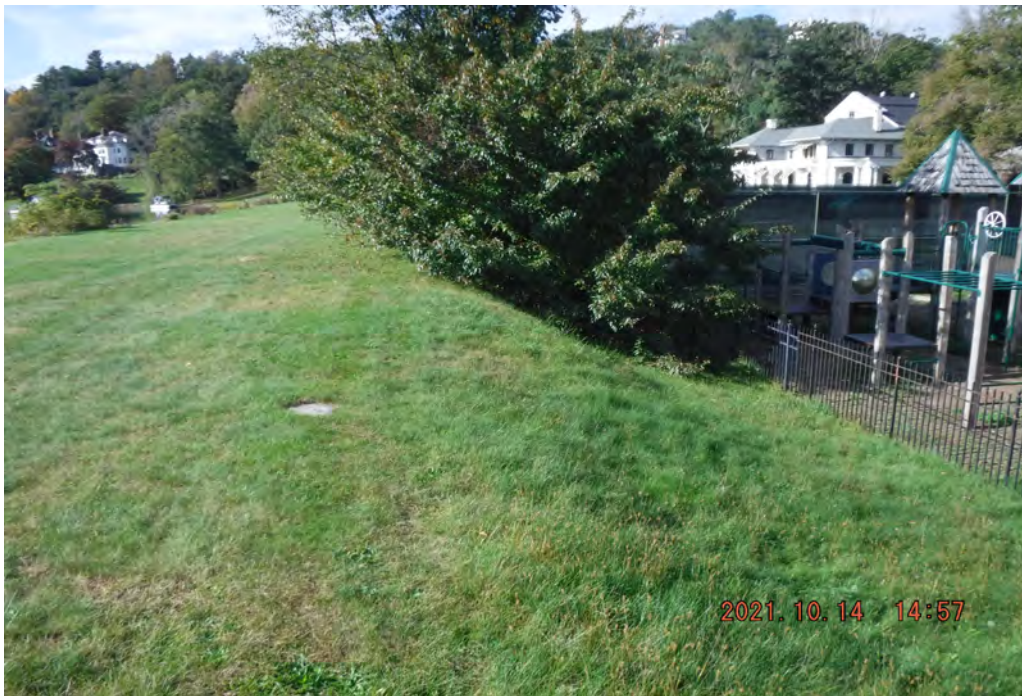
Photo 6 Dam ID# 196-0354 Tuxedo Lake Dam 10/14/2021
Downstream slope
View looking left from service spillway

- Observed large brush and saplings growing on the downstream slope between the spillway and the tennis courts.
- Rest of downstream slope appears grass covered and well maintained.

In general, the inspection revealed that the dam is being maintained in good condition. There is good grass coverage, no visible signs of distress in the embankments or spillways and no apparent signs of seepage. However, it was noted during our inspection, undesirable growth (large brush and woody vegetation) is beginning to take hold in isolated areas of both the upstream and downstream slopes and small brush noted growing up between the rip on the upstream slope. Overall, you should continue to keep the vegetation cut down low to not allow larger brush and woody vegetation to become established as part of the on-going ordinary maintenance of the dam.

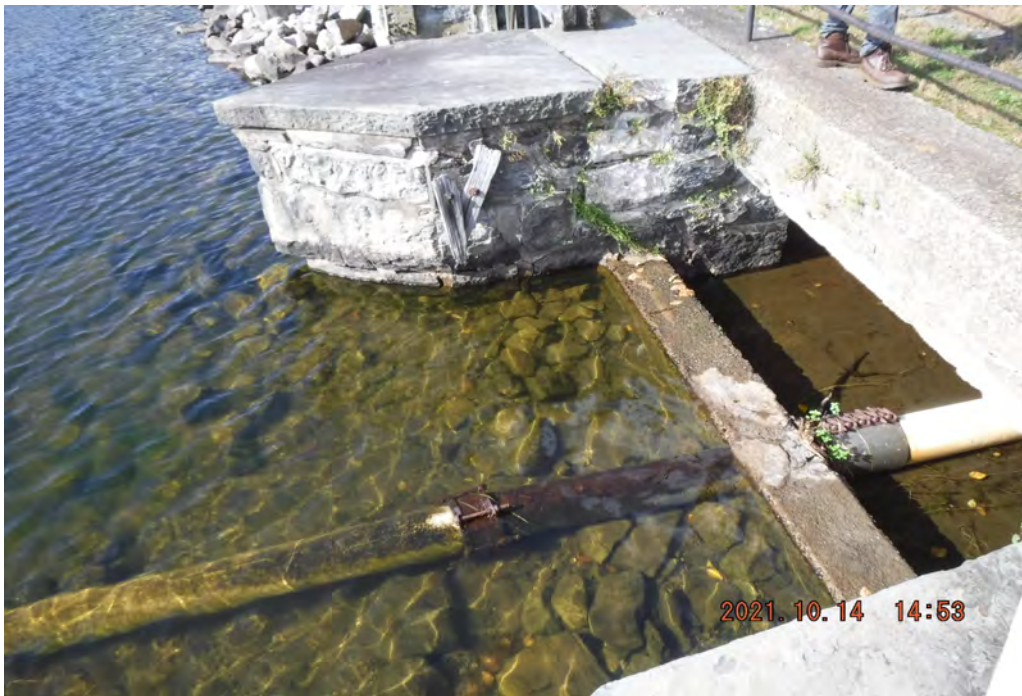
Photo 8 Dam ID# 196-0354 Tuxedo Lake Dam 10/14/2021
Right spillway
View looking left from right side of spillway

- Left spillway bay has stop log in place. Mechanism to lift stop log appears to be non-functional.
- Right spillway bay has concrete sill and siphon pipe. Concrete sill elevation same as left spillway bay with board/stop log in place.
- Downstream drop-off and plunge pool appear OK
- Ground surface was wet and observed flow on the right downstream side of outlet. Assume flow from one of the 3 weep pipes on the right downstream side. Could not determine which of the drains were flowing.
