MEMORANDUM

SUBJECT: Wee Wah Lake, Tuxedo Lake, and Pond 3 Trunk Sewer Investigation

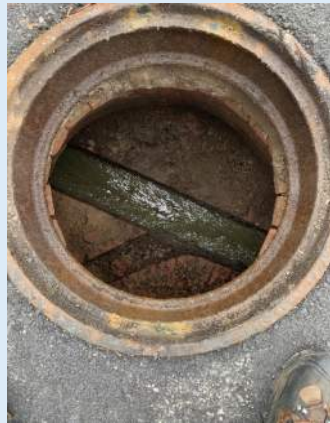
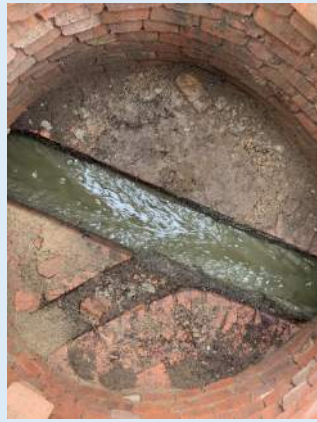
Bench and Invert Infiltration	None
Pipe Connection Infiltration	None
Additional Comments	Lateral invert blocked with soil. No flow, appears abandoned
Location Coordinates (click white space below to obtain)

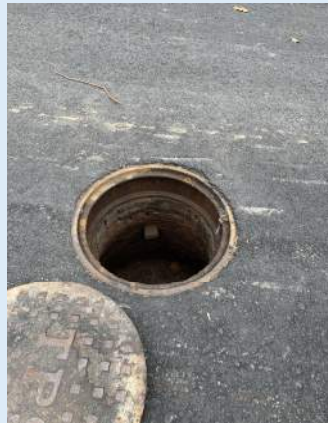
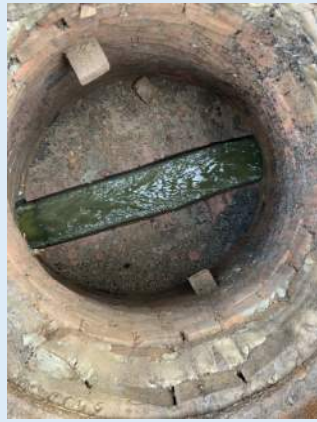
Record: 74	
Client	Village of Tuxedo Park, New York
Project Title	Village of Tuxedo Park Trunk Sewer Inspection
Inspection Date	2021-03-17
Inspector	Anton Patton
Sewer	Village of Tuxedo Park Trunk Sewer
Manhole	EAST-0070
Location	Continental Road
Street or Easement	Street
Surface Type	Asphalt
MH Inspection Status	Inspected
Number of Inverts	2
Signs of Surcharge	NO
Surge Plate	NO
Cover Type	Standard
Cover Material	Cast Iron
Cover Condition	OK
Frame Material	Cast Iron
Frame Condition	OK
Riser Rings	Other
Other Number of Riser Rings	0
MH Cover Elevation At Grade	At Grade
Cover Inflow	None
MH cleaning Required	NO
MH Grease Visible	NO
Roots	NO
Steps	NO
Chimney Material	Brick
Chimney Condition	Needs Repair
Chimney Infiltration	None
Cone Material	Brick
Cone Condition	Needs Repair
Cone Infiltration	None
Wall Material	Brick
Wall Condition	Needs Repair
Wall Infiltration	None
Bench and Invert Material	Brick
Bench and Invert Condition	Needs Repair

Bench and Invert Infiltration	None
Pipe Connection Infiltration	None
Additional Comments	Brick showing signs of aging.
Location Coordinates (click white space below to obtain)

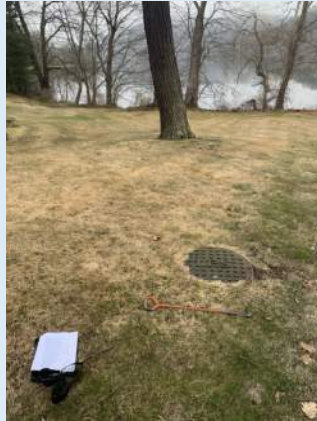
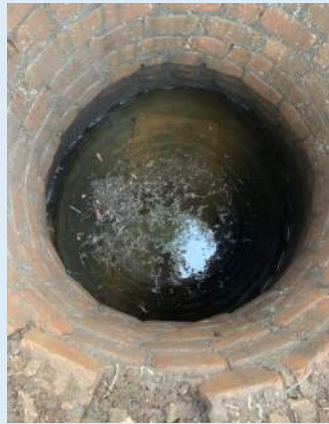
Bench and Invert Infiltration	None
Pipe Connection Infiltration	None
Additional Comments	Filled with 2' of water.
Location Coordinates (click white space below to obtain)

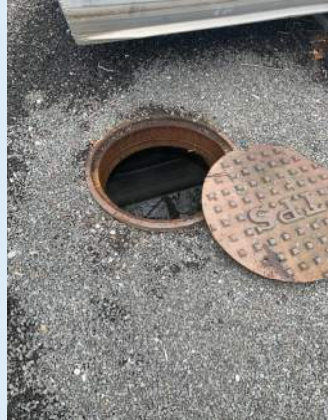
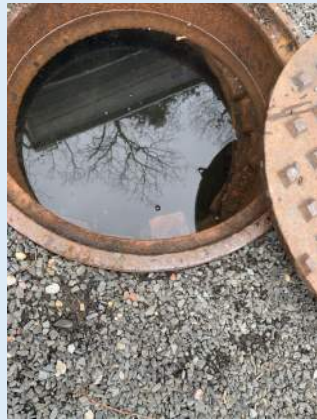
Record: 77	
Client	Village of Tuxedo Park, New York
Project Title	Village of Tuxedo Park Trunk Sewer Inspection
Inspection Date	2021-03-17
Inspector	Anton Patton
Sewer	Village of Tuxedo Park Trunk Sewer
Manhole	EAST-0340
Location	E Lake Road
Street or Easement	Easement
Surface Type	Other
Other Surface Type	Loose small stone, parking lot
MH Inspection Status	Inspected
Number of Inverts	2
Signs of Surcharge	NO
Surge Plate	YES
Cover Type	Standard
Cover Material	Cast Iron
Cover Condition	OK
Frame Material	Cast Iron
Frame Condition	OK
Riser Rings	Other
Other Number of Riser Rings	0
MH Cover Elevation At Grade	Below Grade
Cover Inflow	None
MH cleaning Required	YES
Chimney Material	Brick
Cone Material	Brick
Cone Condition	Needs Repair
Cone Infiltration	Heavy
Wall Material	Brick
Bench and Invert Material	Brick
Additional Comments	Unable to complete survey of manhole due to being full of water. Surge plate working and stopping inflow from reaching sewer main. There is a hole in the cone just below the frame on the east side allowing stone and water freely into the structure.
