# NEW YORK STATE DEPARTMENT OF ENVIRONMENTAL CONSERVATION

January 14, 2022

Re: Lower Wee-Wah Lake Dam  
DEC Dam ID#: 196-0361, Class C – High Hazard  
Village of Tuxedo Park, Orange County  
**Condition Rating: No Deficiencies Noted**

**Visual Observations**

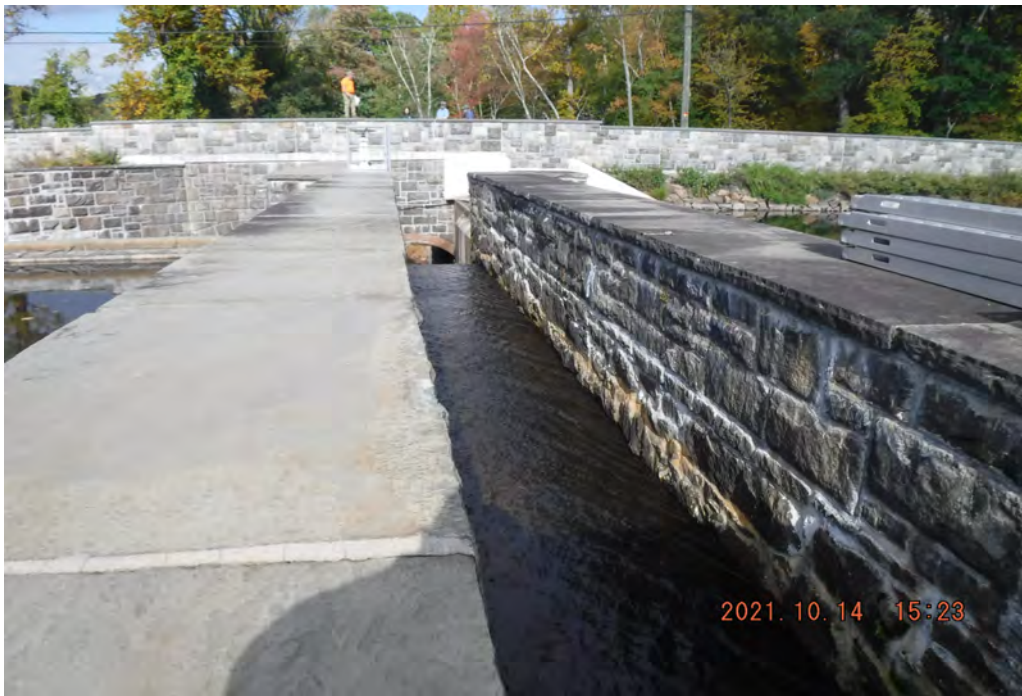
**Photo 9 Dam ID# 196-0361 Lower Wee-wah Lake Dam 10/14/2021**  
Primary spillway inlet with stop logs  
View looking upstream from left side

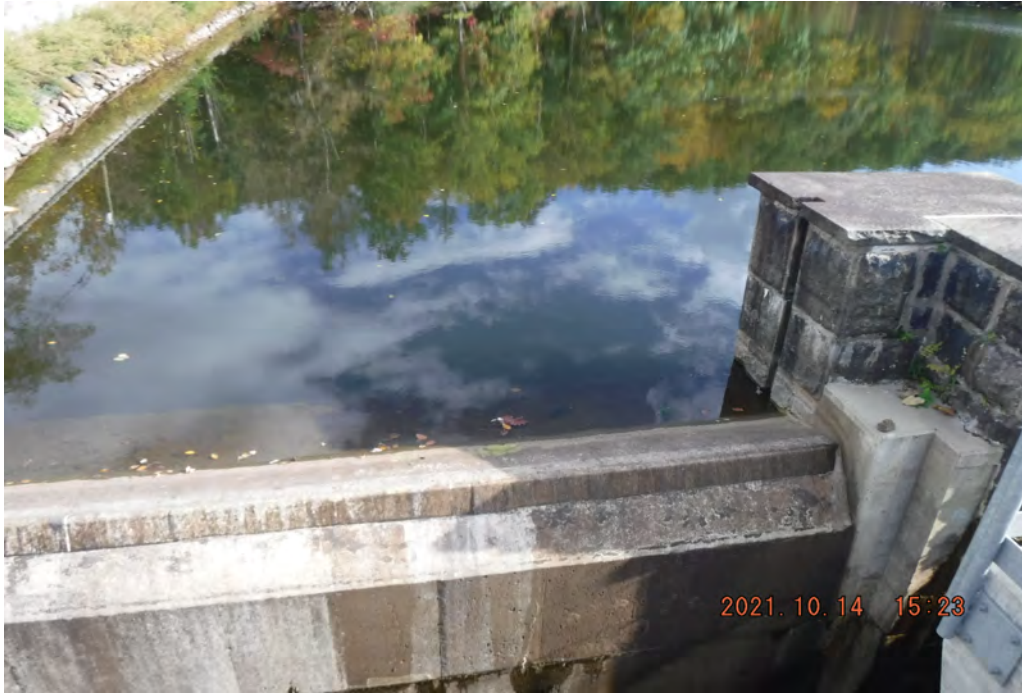
**Photo 10 Dam ID# 196-0361 Lower Wee-wah Lake Dam 10/14/2021**  
Spillway channel  
View looking downstream from spillway inlet

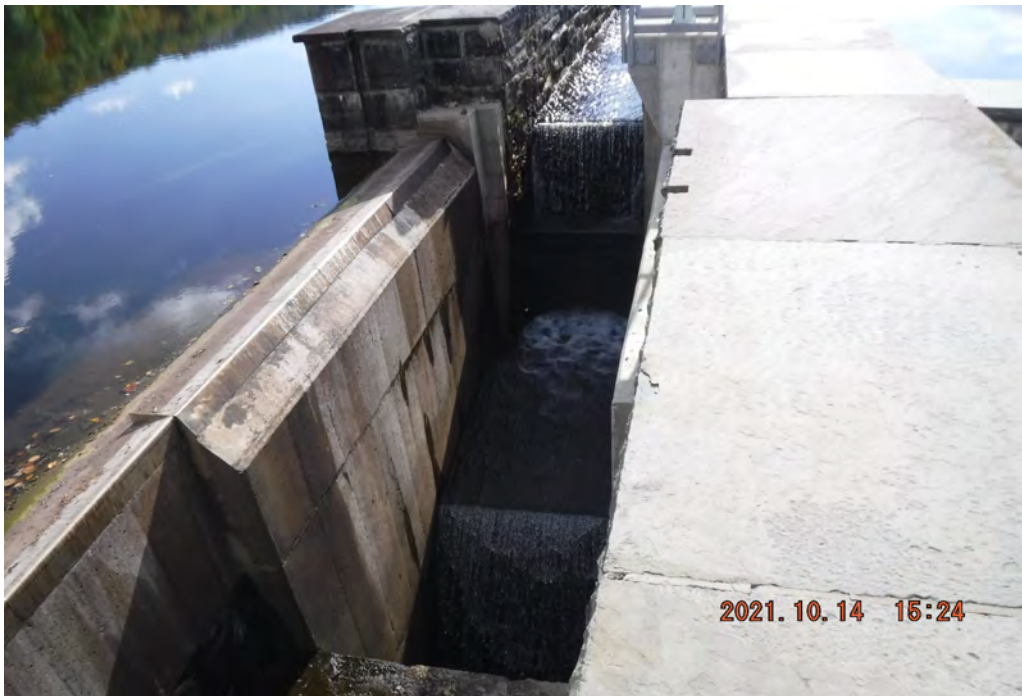
**Photo 11 Dam ID# 196-0361 Lower Wee-wah Lake Dam 10/14/2021**  
Secondary spillway on right side of spillway channel  
View looking right from left side

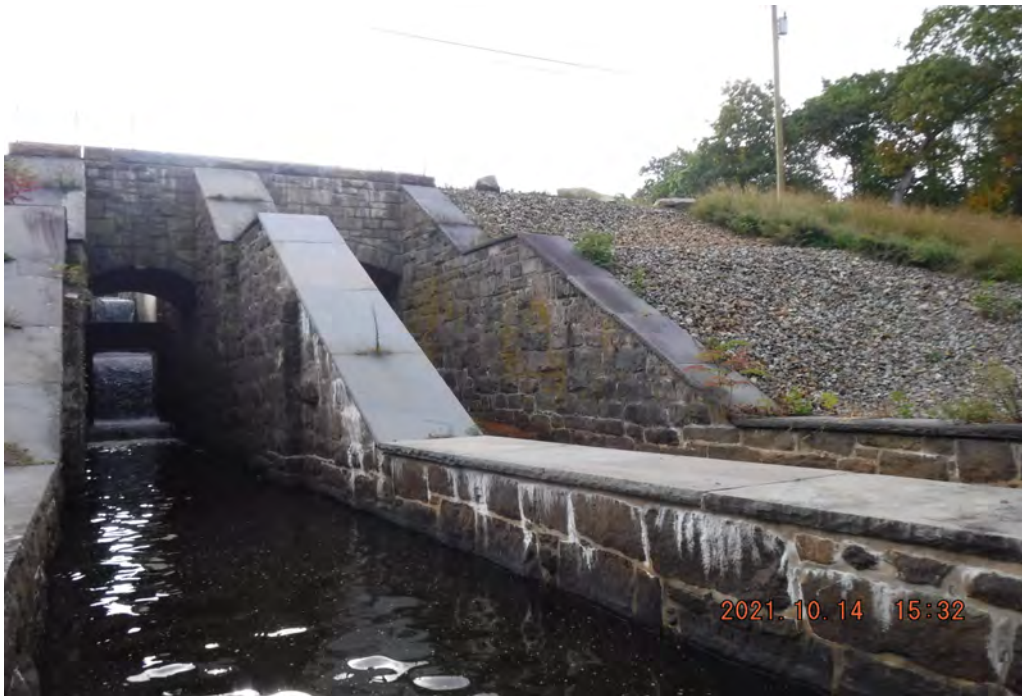
**Photo 12 Dam ID# 196-0361 Lower Wee-wah Lake Dam 10/14/2021**  
Spillway outlet channel  
View looking upstream from left side of channel

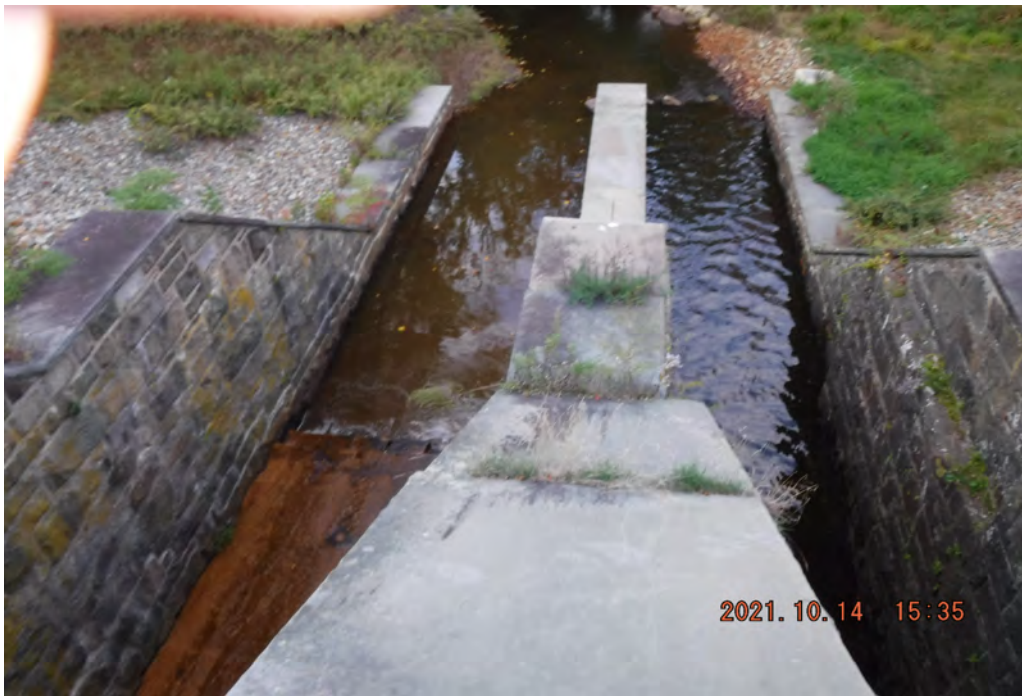
**Photo 13 Dam ID# 196-0361 Lower Wee-wah Lake Dam 10/14/2021**  
Spillway outlets  
View looking upstream from downstream right side
