MEMORANDUM

SUBJECT: Wee Wah Lake, Tuxedo Lake, and Pond 3 Trunk Sewer Investigation

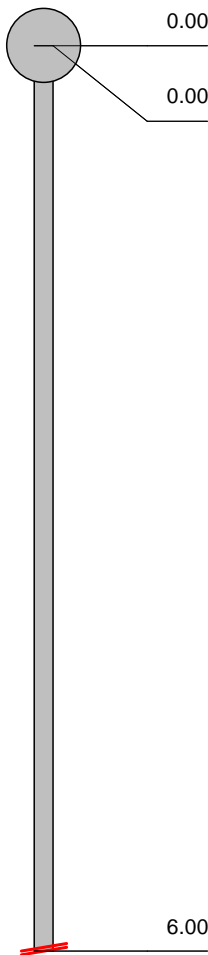
1:50	Distance	Code	Observation	Counter	Photo	Grade
EAST-0500

0.00	AMH	Manhole, EAST-0500 / EAST-0500	00:00:06		
	0.00	MWL	Water Level, 10% of the vertical dimension	00:00:16		
	6.00	MSA	Survey Abandoned, CAN NOT GET PAST 90 / CAN NOT GET PAST 90	00:01:44		
QSR	QMR	QOR	SPR	MPR	OPR	SPRI
						MPRI
						OPRI
